## ***Testing and Analysis of Components for 3-Ring Systems***

Presented by Patrick Pollin, Tim Tylaska, and Tom Dixon

## ***Tylaska Components for 3-Ring Release***

## *Stainless Steel 3-Ring Testing and Analysis*

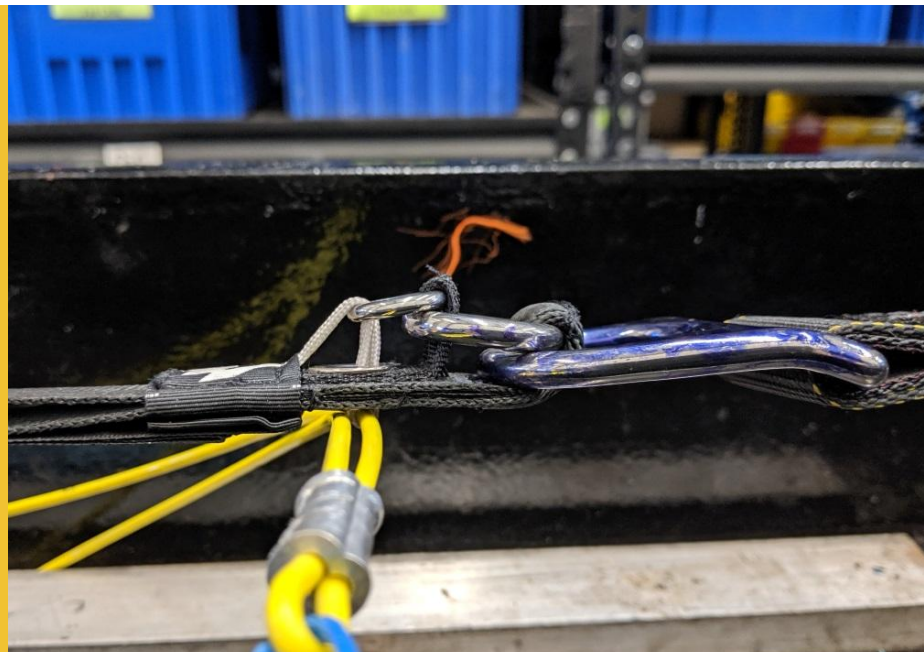
## ***Tylaska 3-Ring Configuration***

- Raw Material: UNS31600 Type 316L Stainless Steel
- Process: Cold Forging
  - No heat treat required
- Finishing: Highly polished gloss stainless
- Quality
  - Destructive test samples from every lot with third party verification.
  - Tylaska is registered to the Aerospace AS9100D quality management standard

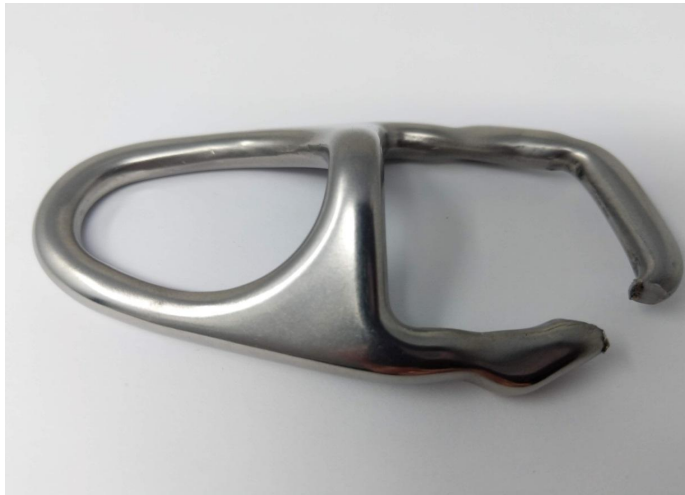
Highly ductile failure  
of an austenitic  
316L stainless steel  
piece

- Unlike traditional hot forging, cold forging substantially increases yield and tensile strengths without the need for heat treating.
- Cold forging can also create a strong outer shell while maintaining a more ductile inner core
- Strengthening inherent to the cold forging process removes the danger of a part unintentionally missing heat treatment
- Parts maintain superior surface finish by avoiding hot forging scale

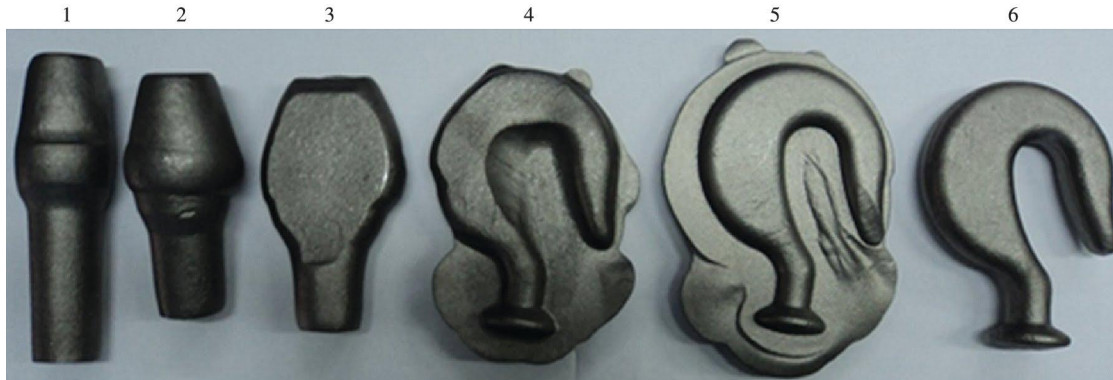
## ***Tylaska Cold Forging Process***

- Austenitic stainless steel can be formed at room temperature using tremendous pressure
- Strain hardening takes place as the raw material deforms and flows under pressure to fill the shape of the mold
- Over 2 million pounds of force are applied to transform the raw material into the desired shape.

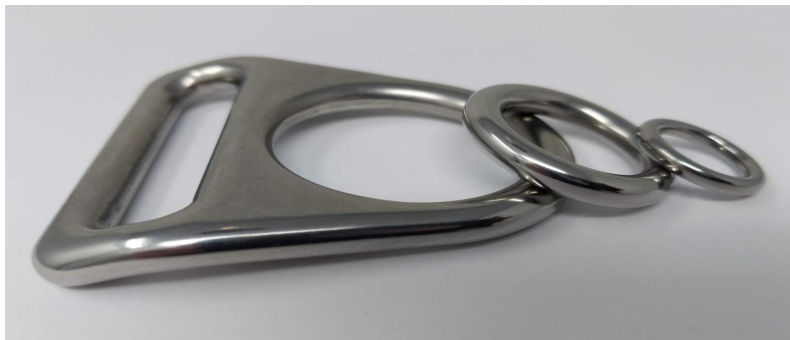
## *Dimensions of Common D-Rings*

Part Type	Raw material	Part no.	Manufacturer	Thickness (mm)	Slot width (mm)	Inside diam. (mm)
Stainless steel D-Ring	316L Stainless Steel	RD46	Tylaska	6.3	44.7	33
Stainless steel D-Ring	316L Stainless Steel	SR-8	CWH	6.3	44.5	33
4140 Steel D-Ring	4140 Steel	Mini D-Ring	Various	6.5	44.7	33

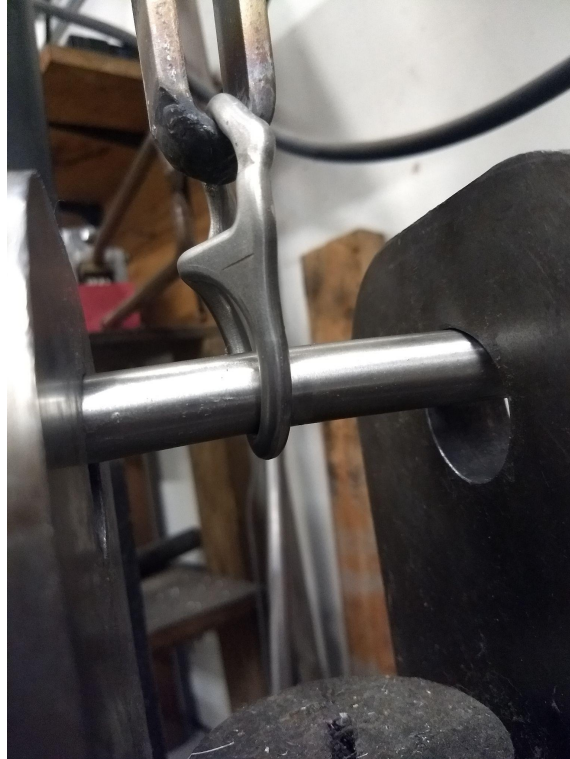
- Cold forged stainless D-Ring at tensile failure; approximately 11,000 lbf

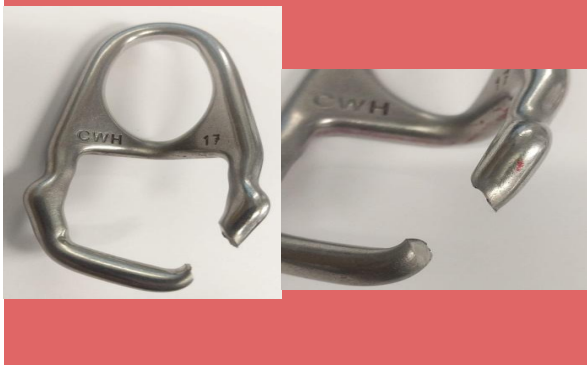
Type	Sample	Breaking Load (lbf)
D-Ring	CWH SR-8	10575
D-Ring	TYLASKA RD46 test sample-01	11386
D-Ring	TYLASKA RD46 test sample-02	10949
D-Ring	TYLASKA RD46 test sample-03	11256
D-Ring	TYLASKA RD46 test sample-04	11213
D-Ring	Std. 4140 Plated Steel	7049

- 10,575 lbf peak load at tensile failure
- Extreme deformation with ductile failure

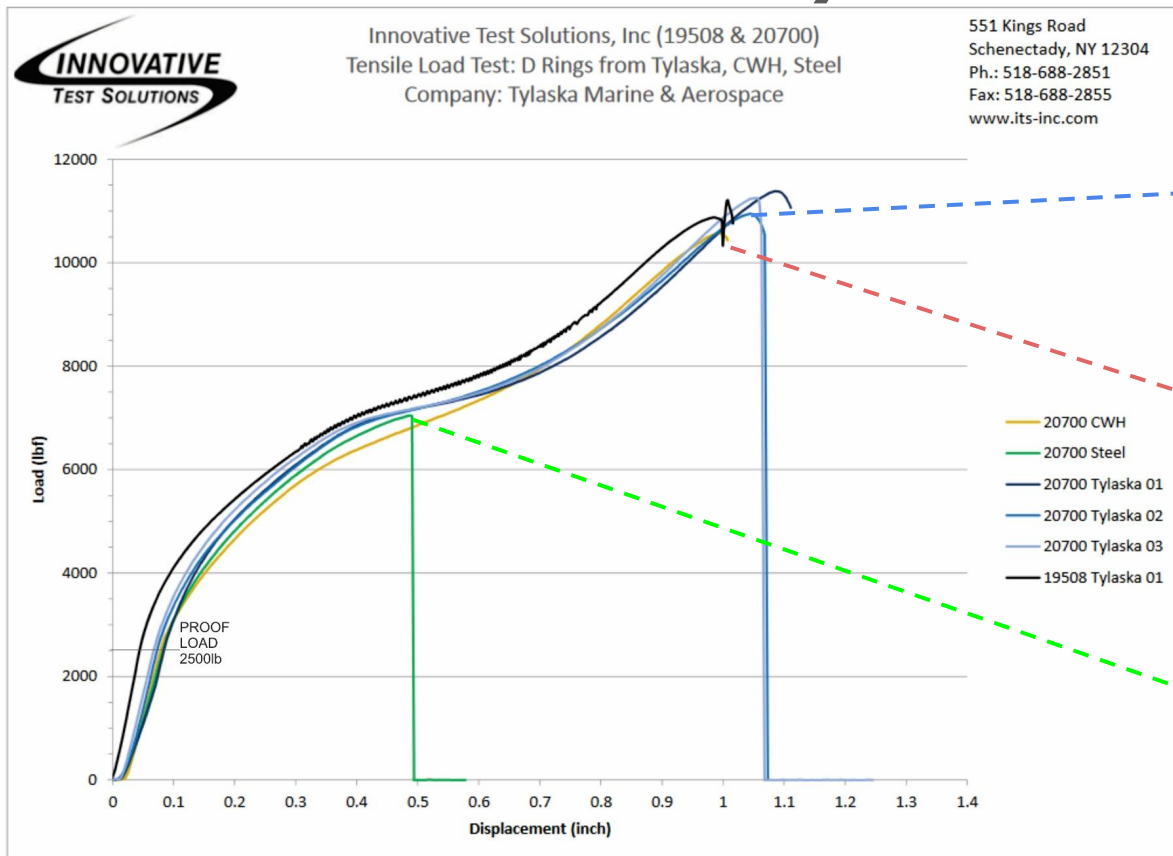
### Tylaska RD46 D-Ring

- 11,386 lbf peak load at tensile failure
- Extreme deformation with ductile failure

### CWH SR-8 D-Ring

### Standard 4140 Steel D-Ring

- Failure at low load with sudden brittle failure
- 7,049 lbf peak load at tensile failure

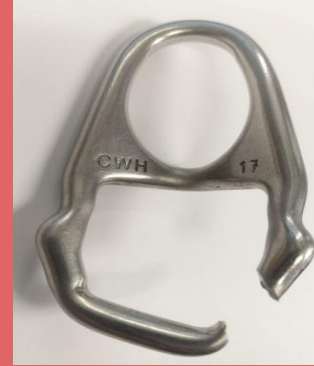
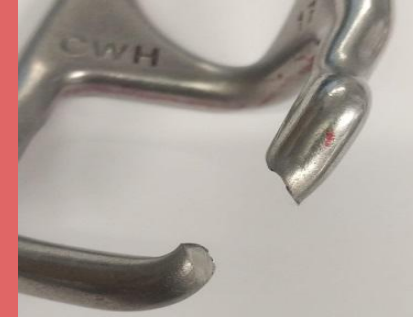
### CWH SR-8

- Ultimate failure at 10,575 lbf
- Ductile deformation provides warning before failure

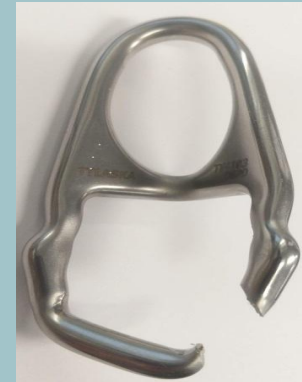
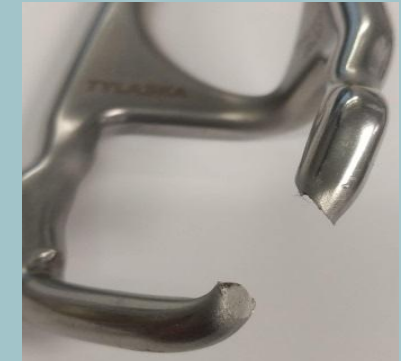
### Tylaska RD46

- Ultimate failures 10,949-11,386 lbf
- Ductile deformation provides warning before failure

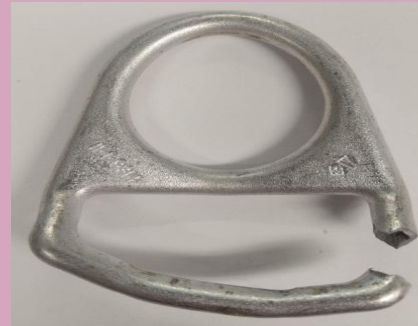
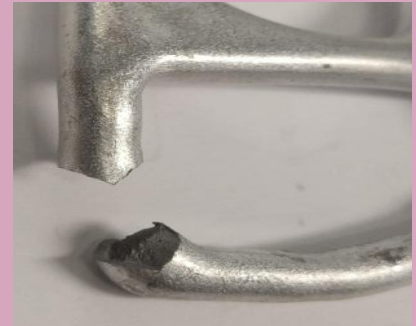
### Standard 4140 Steel D-Ring

- Ultimate failure at only 7,049 lbf
- Brittle failure with fracture at webbing slot. Little deformation and no warning prior to failure

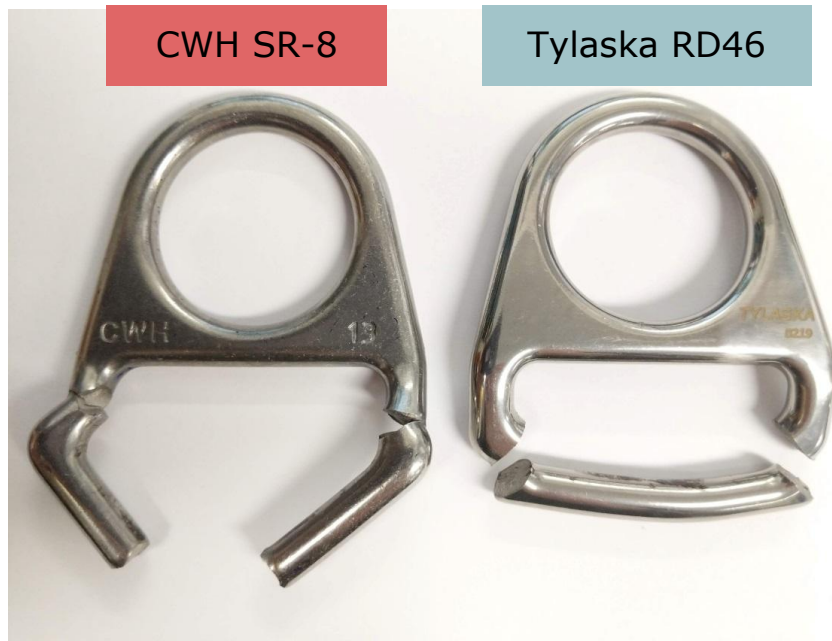
- High cycle repetitive loading from 0 lbf - 2000 lbf

Part type	Model	Loading	Cycles to failure
D-Ring	CWH SR-8	0 lbf-2000 lbf	17,784
D-Ring	Tylaska RD46	0 lbf-2000 lbf	36,643

- In parachute riser applications, fatigue test results show that D-Ring will be intact beyond point of riser failure
- Tylaska parts exceed industry standard

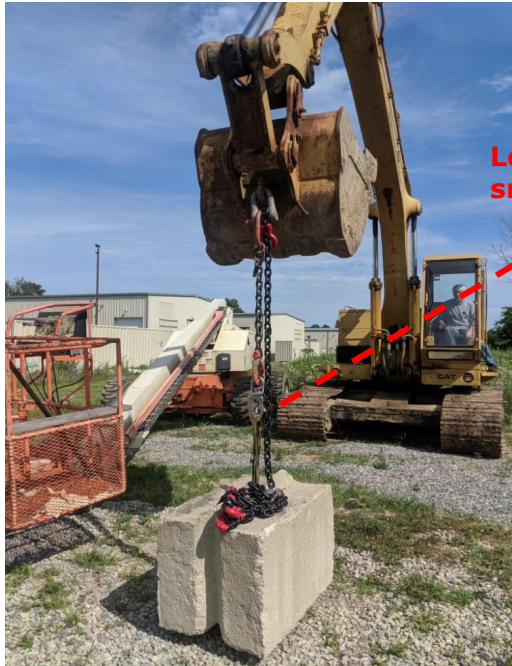
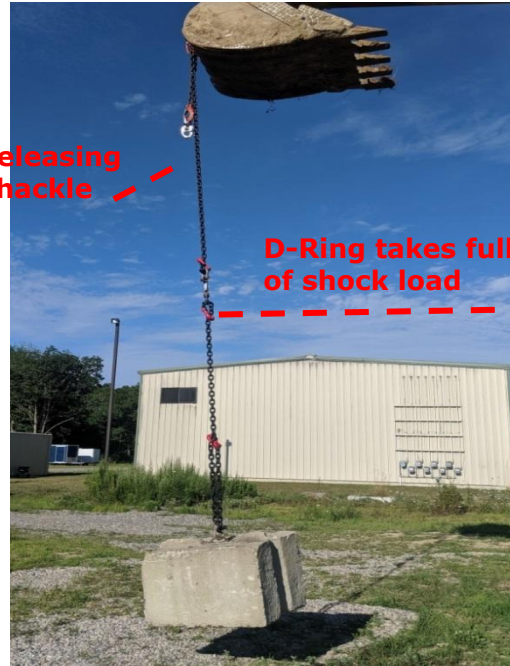
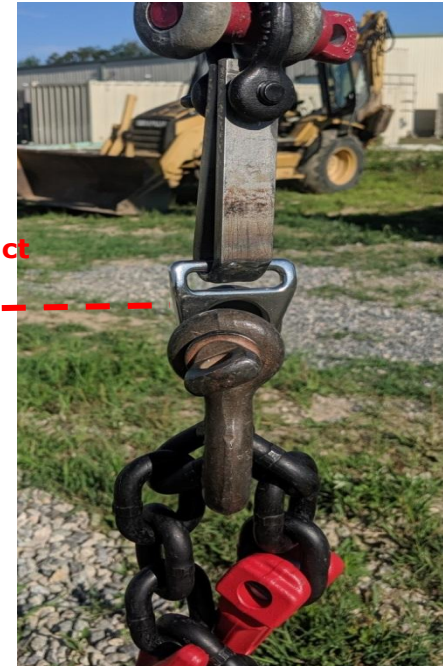
- Concrete block drops and suddenly stops on rigid chain to produce severe shock loading
- 1,600 lb block drops 10 ft and comes to sudden stop while connected to D-Ring

Load-releasing  
snap shackle

D-Ring takes full impact  
of shock load

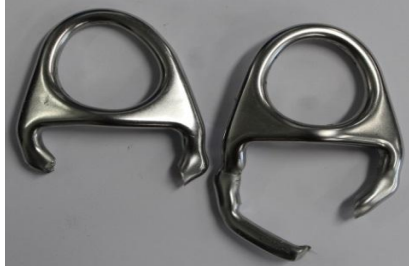
- Tylaska D-Ring RD46
  - Highly ductile failure under shock. Displays severe deformation

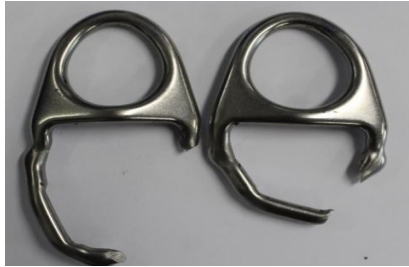
- CWH D-Ring SR-8
  - Highly ductile failure under shock. Displays severe deformation

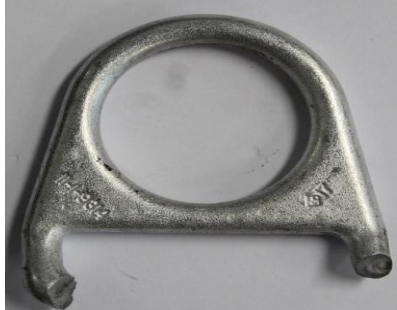
- Standard steel No.8 D-Ring
  - Brittle failure at webbing slot. Little deformation displayed at failure

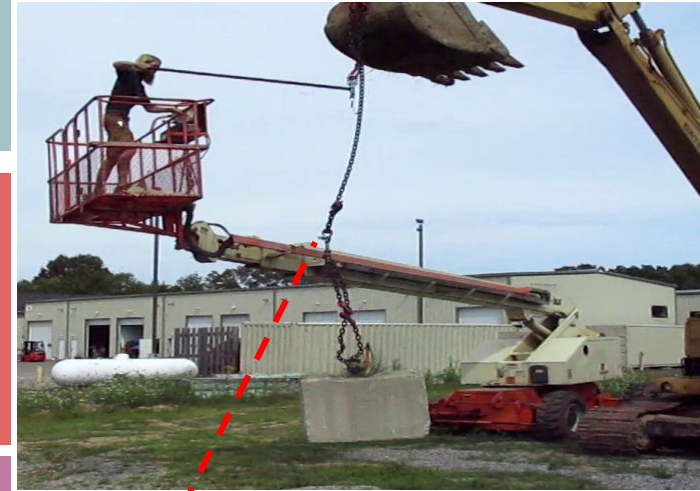
**D-Ring takes full impact  
of shock load**

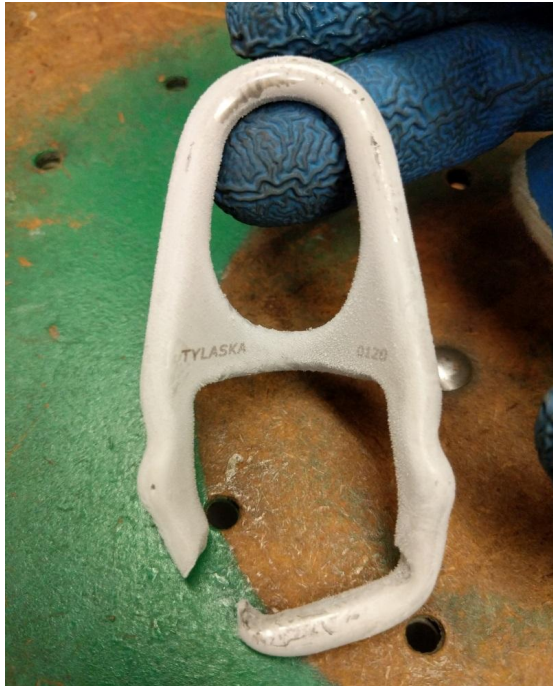
Part type	Model	Temperature	Breaking Load (lbf)
D-Ring	Tylaska RD46	-70°F	14,270

- Result: Ductile failure comparable to normal room temperature test.
- Breaking strength increases at low temperatures
- Conclusion: Suitable for use at extreme altitudes

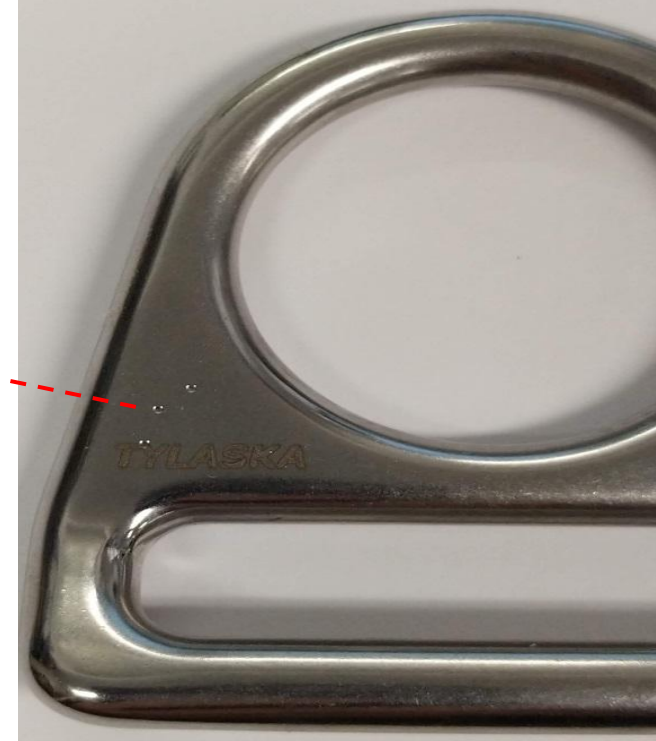
- Surface hardness is an indicator of material strengthening
- Example of impressions left from hardness tests

Part type	Model	Surface Hardness
D-Ring	CWH SR-8	99-103 Rockwell B
D-Ring	Tylaska RD46	98-103 Rockwell B
D-Ring	4140 Steel	40 Rockwell C (hardened by Heat Treatment)

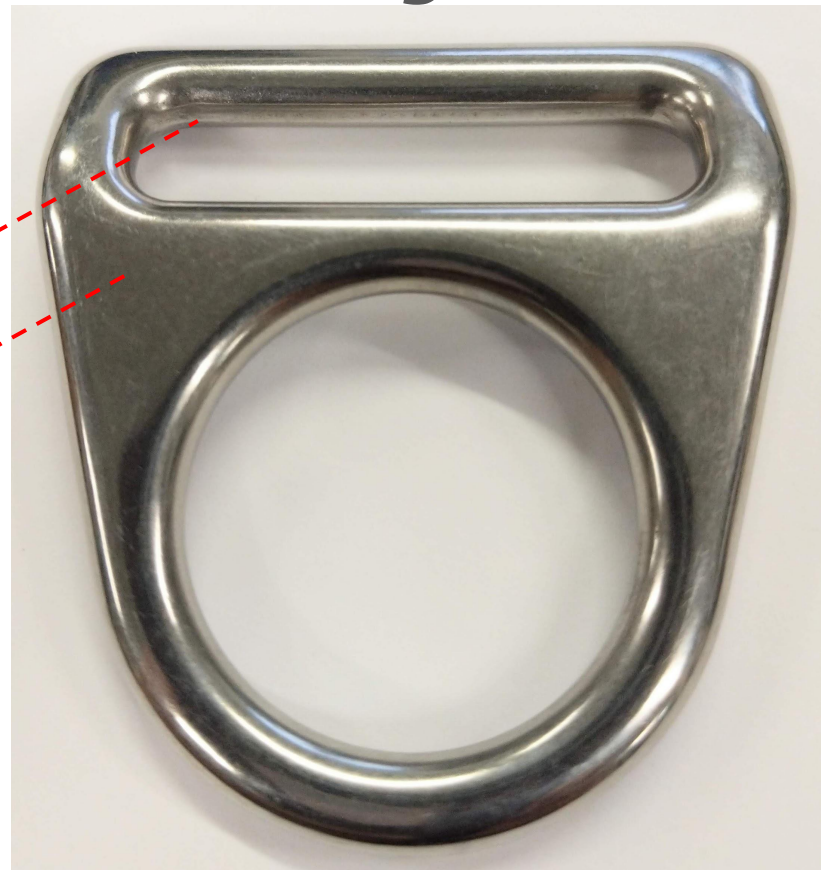
- Rings must be free of burrs and sharp edges in order to be safe for use with webbing products
- Inspection of critical areas in slot interior
- Smooth, polished surface prevents abrasion and corrosion

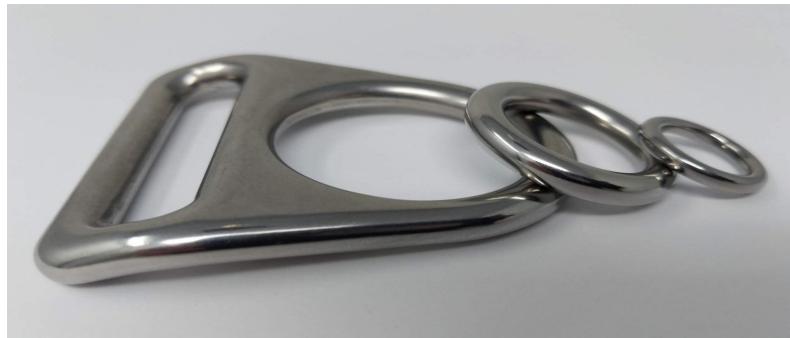
## *Dimensions of Common Middle Rings*

Part Type	Raw material	Part no.	Manufacturer	Thickness (mm)	Outside diam. (mm)	Inside diam. (mm)
Stainless Steel Middle Ring	316L Stainless Steel	R30	Tylaska	5	30	20
Stainless Steel Middle Ring	316L Stainless Steel	SR-5009	CWH	5	30	20
4140 Steel Middle Ring	4140 Steel	No. 3	Various	5	31.6	21.9

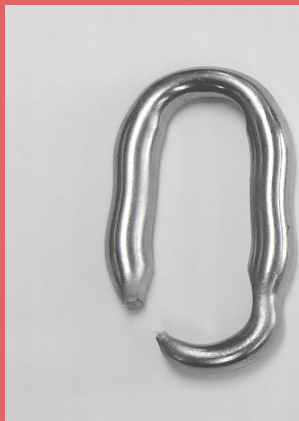
Type	Sample	Breaking Load (lbf)	Observations
Middle Ring	CWH 5009	7555	Ductile failure
Middle Ring	Tylaska R30 -01	7540	Ductile failure
Middle Ring	Tylaska R30 -02	7533	Ductile failure
Middle Ring	Tylaska R30 -03	7488	Ductile failure
Middle Ring	Std. Steel ring	2397	Brittle failure

- CWH 5009 Middle Ring**
- 7,555 lbf peak load at tensile failure
  - Extreme deformation with ductile failure

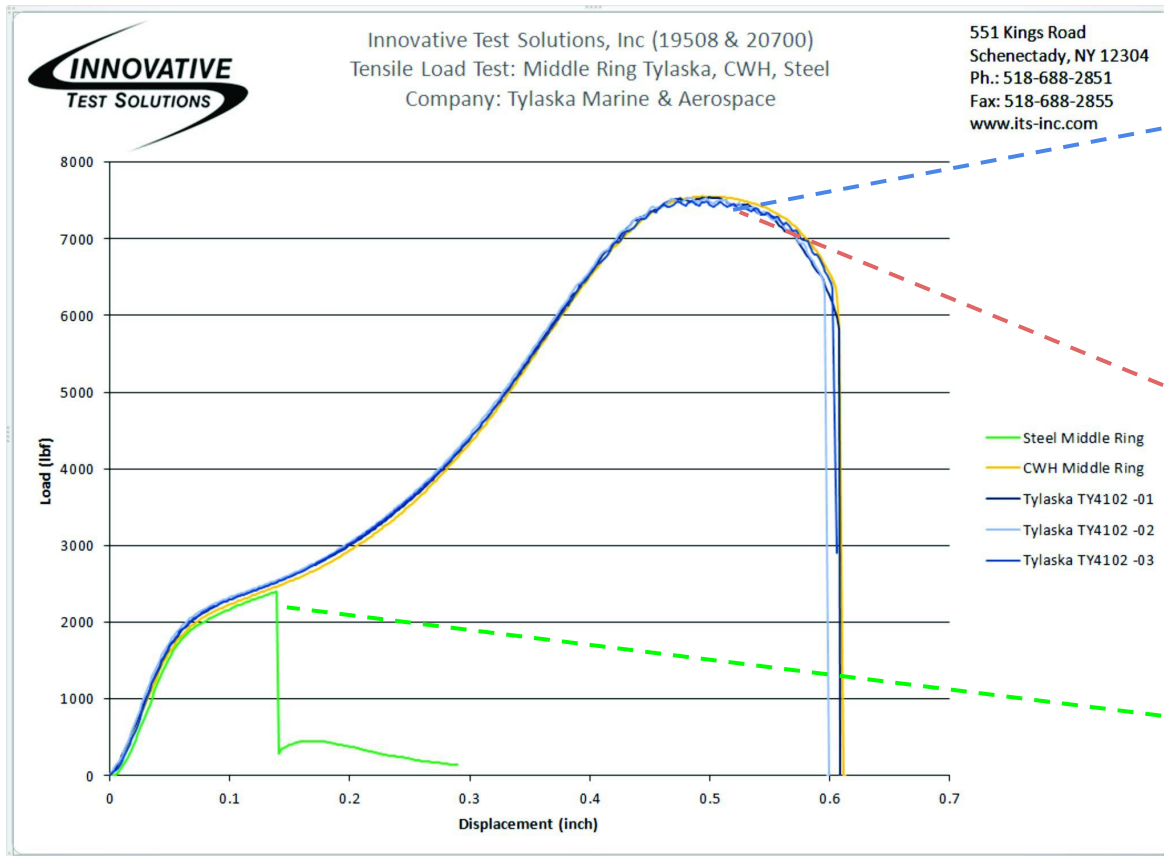
- Tylaska R30 Middle Ring**
- 7,540 lbf peak load at tensile failure
  - Extreme deformation with ductile failure

- Standard 4140 Steel Middle Ring**
- 2,397 lbf peak load at tensile failure
  - Low tensile failure at  $\frac{1}{3}$  load of cold forged parts
  - Little deformation warning before brittle failure

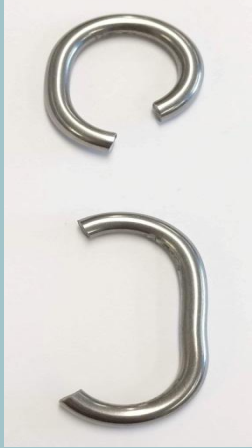
Part type	Model	Loading	Cycles to failure
Middle Ring	CWH 5009	0 lbf-1100 lbf	24,070
Middle Ring	CWH 5009	0 lbf-1100 lbf	28,472
Middle Ring	Tylaska R30	0 lbf-1100 lbf	22,267
Middle Ring	Tylaska R30	0 lbf-1100 lbf	25,350

- In parachute riser applications, fatigue test results show that middle ring will be intact well beyond point of riser failure
- Tylaska parts meet industry standard

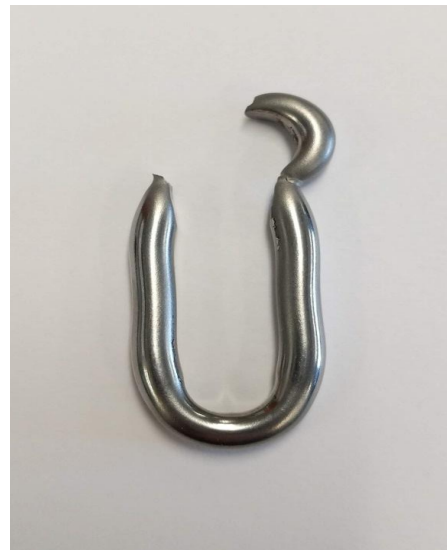
- Sample: Tylaska 316L R30 Middle Ring
- Result: Ductile failure comparable to normal room temperature test.
- Breaking strength increases from 7,500 lbf to 8,640 lbf.
- Conclusion: Suitable for use at extreme altitudes

Part type	Model	Temperature (°F)	Breaking Load (lbf)
Middle Ring	Tylaska R30	-70°F	8,640

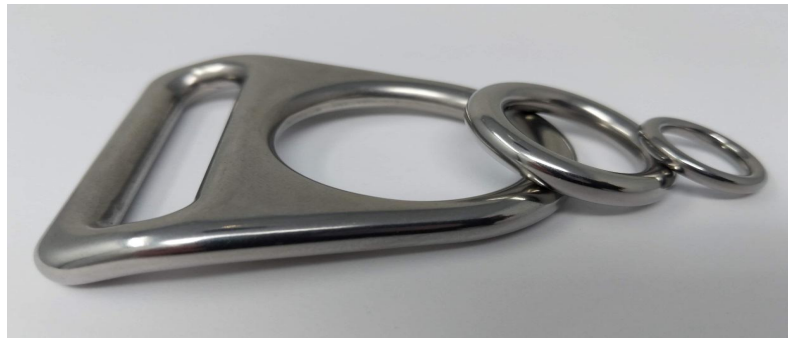
## *Dimensions of Common Small Rings*

Part Type	Raw material	Part no.	Mfg.	Thickness (mm)	Outside diam. (mm)	Inside diam. (mm)
Small Ring	316L stainless steel	R19	Tylaska	3	19	13
Small Ring	316L stainless steel	SR-4	CWH	3	19	13
Small Ring	4140 Steel	No. 4	Various	3	20.3*	14

\*Note: Steel small ring 20.3mm OD is not compatible with Stainless Middle Rings' 20mm ID!  
These parts will not assemble and are not compatible.

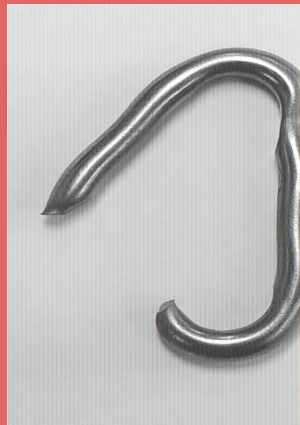
Type	Sample	Breaking Load (lbf)
Small Ring	CWH SR-4	2956
Small Ring	Tylaska R19 -01	2911
Small Ring	Tylaska R19 -02	2928
Small Ring	Tylaska R19 -03	2950
Small Ring	Standard 4140 Steel No.4	1154

- CWH No.4 Small Ring**
- 2,956 lbf peak load at tensile failure
  - Extreme deformation with ductile failure

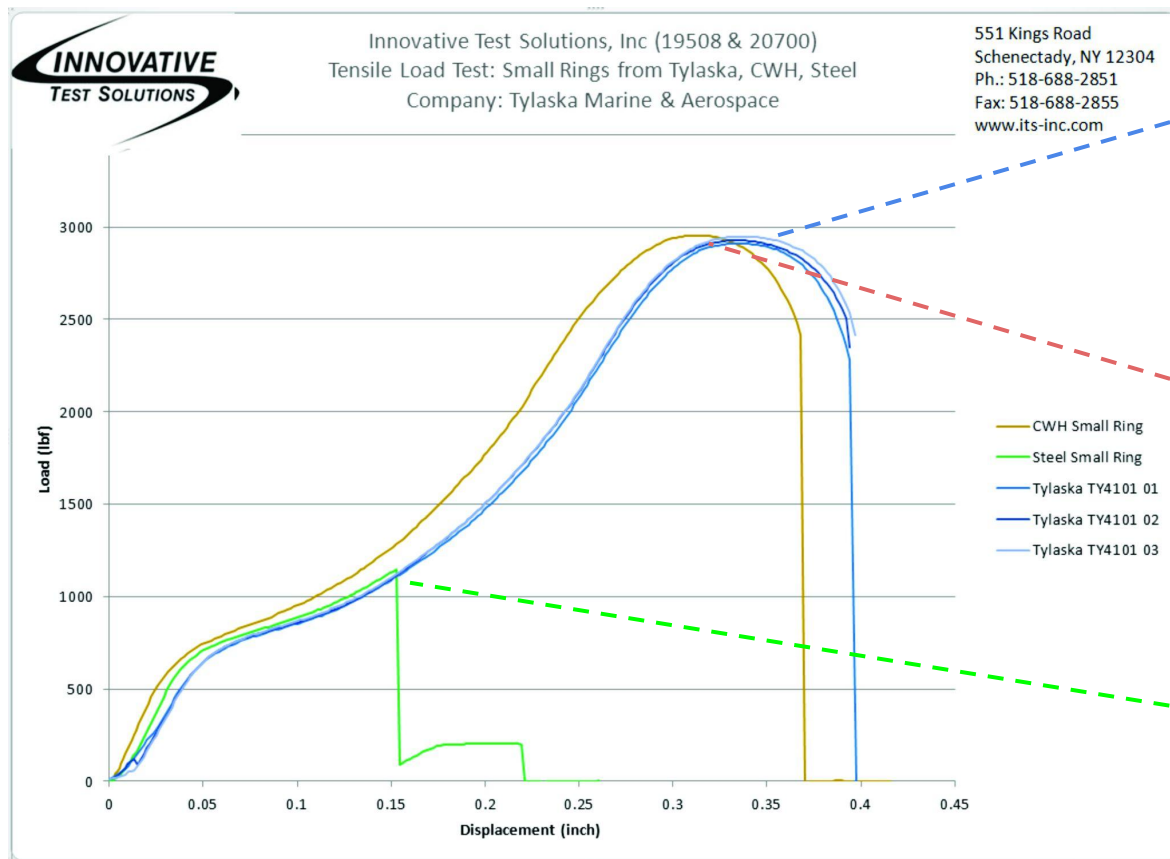
- Tylaska R19 Small Ring**
- 2,950 lbf peak load at tensile failure
  - Extreme deformation with ductile failure

- Standard 4140 Steel Small Ring**
- 1,154 lbf peak load at tensile failure
  - Low tensile failure at less than 1/2 the load of cold forged parts
  - Little deformation warning before brittle failure

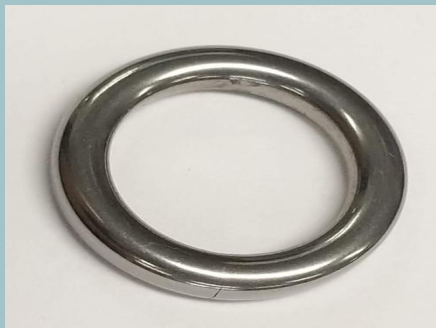
Part type	Model	Loading	Cycles to failure
Small Ring	CWH SR-4	20 lbf-500 lbf	18,053
Small Ring	CWH SR-4	20 lbf-500 lbf	18,147
Small Ring	CWH SR-4	20 lbf-500 lbf	13,547
Small Ring	Tylaska R19	20 lbf-500 lbf	50,392
Small Ring	Tylaska R19	20 lbf-500 lbf	28,571
Small Ring	Tylaska R19	20 lbf-500 lbf	31,449
Small Ring	Tylaska R19	20 lbf-500 lbf	44,373
Small Ring	Tylaska R19	20 lbf-500 lbf	40,807

- In parachute riser applications, fatigue tests show that small ring will remain intact beyond the point of riser failure
- Tylaska parts exceed industry standard

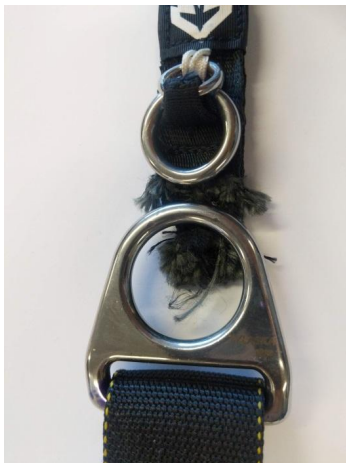
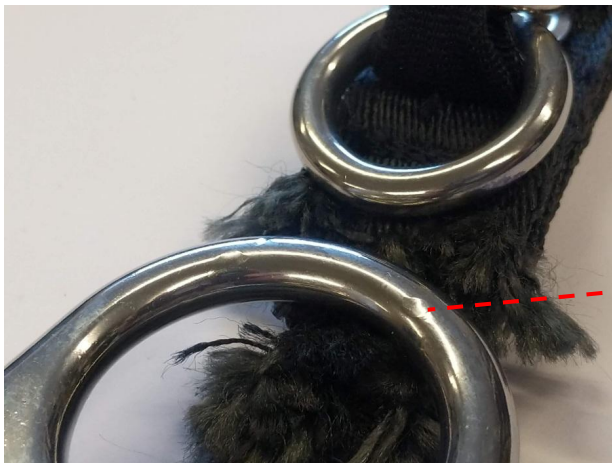
- Riser fails above 4000 lbf without deformation of the rings
- Note: Impressions visible on D-Ring can be used to identify extreme overloading of riser

Part type	Components	Configuration	Breaking load (lbf)
Type 17 Mini 3-Ring Riser	CWH SR-4, SR-5009, CWH SR-8	Tensile break test	4192
Type 17 Mini 3-Ring Riser	Tylaska R19, R30, RD46	Tensile break test	4080
Type 8 3-Ring Riser	Tylaska R19, R30, RD46	Tensile break test	4410

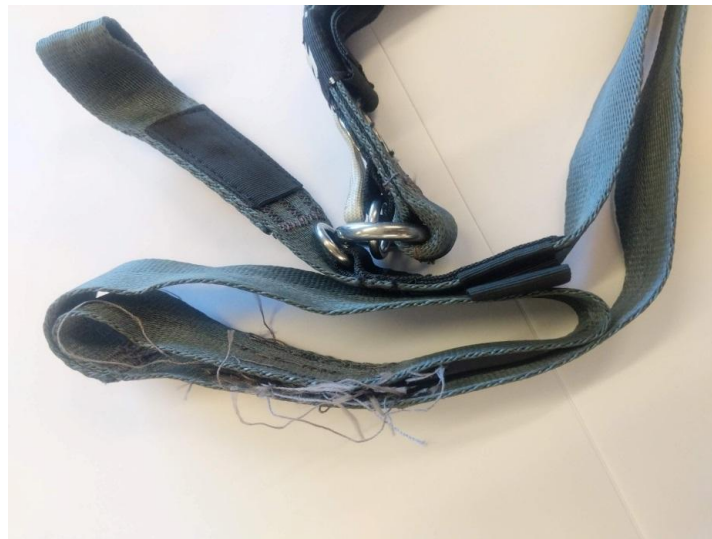
- High cycle loading at 725 lbf with D-Ring connection
- Failure mode: riser failure at stitching on front side loop.
- Conclusion: Fatigue test shows that forgings are intact after point of riser failure

Part type	Components	Fatigue Loading	Fatigue life
Type 17 Mini 3-Ring Riser	Tylaska R19, R30, RD46 rings	0 lbf to 725 lbf	11,697 cycles

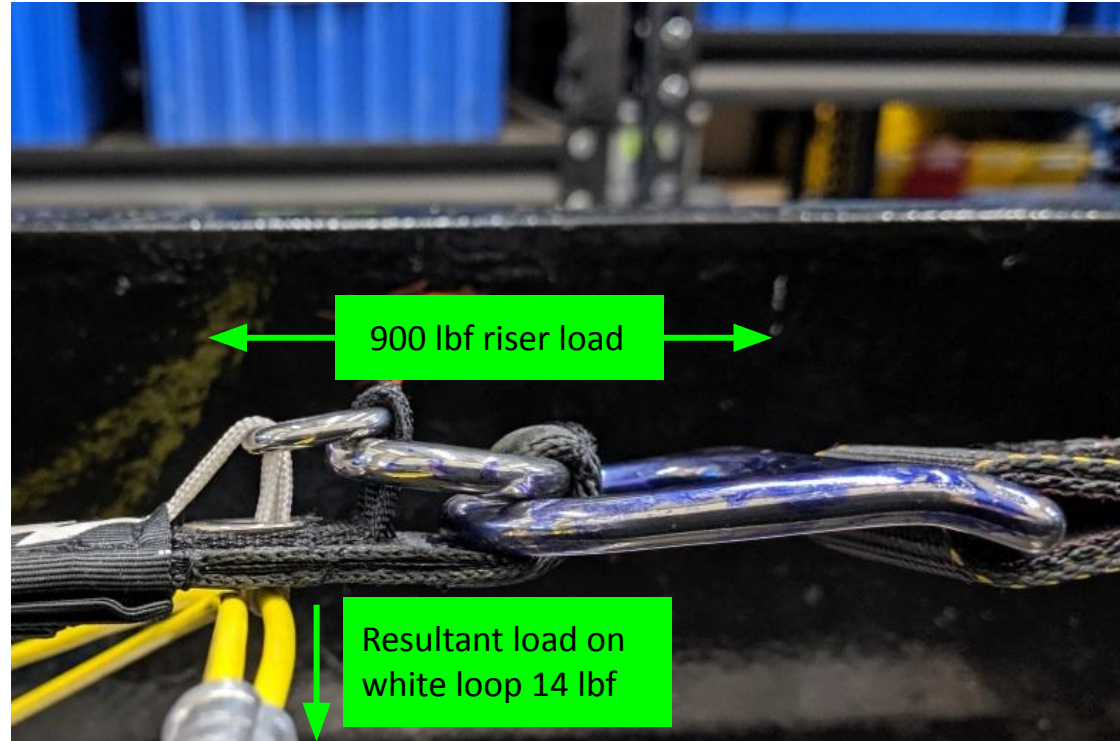
- Type 17 riser assembled with 3-Rings
- 3-ring mechanical advantage measures approximately 64:1 at high loads
- 900 lbf riser loading places 14 lb tension on white loop

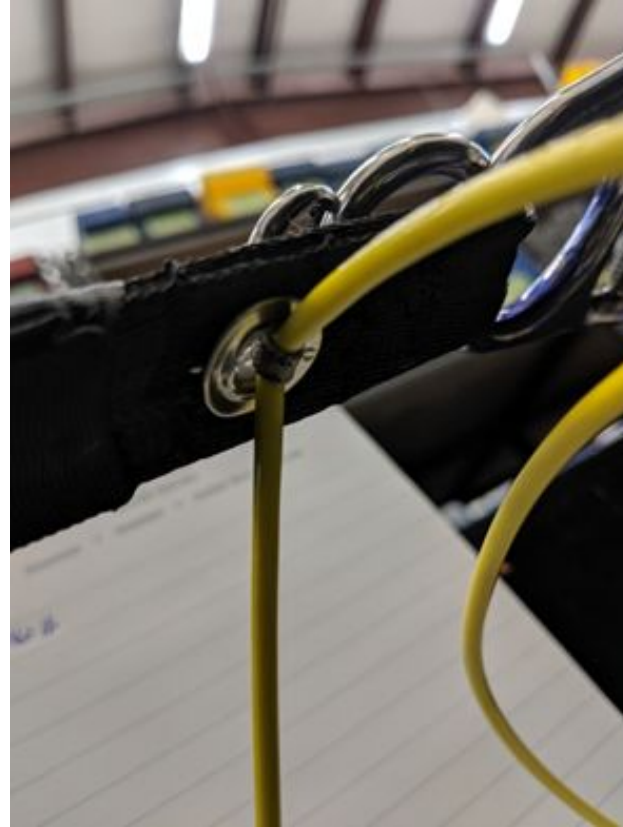
- Cut-away function successfully tested at 1,000 lbf riser loading
  - Immediate release

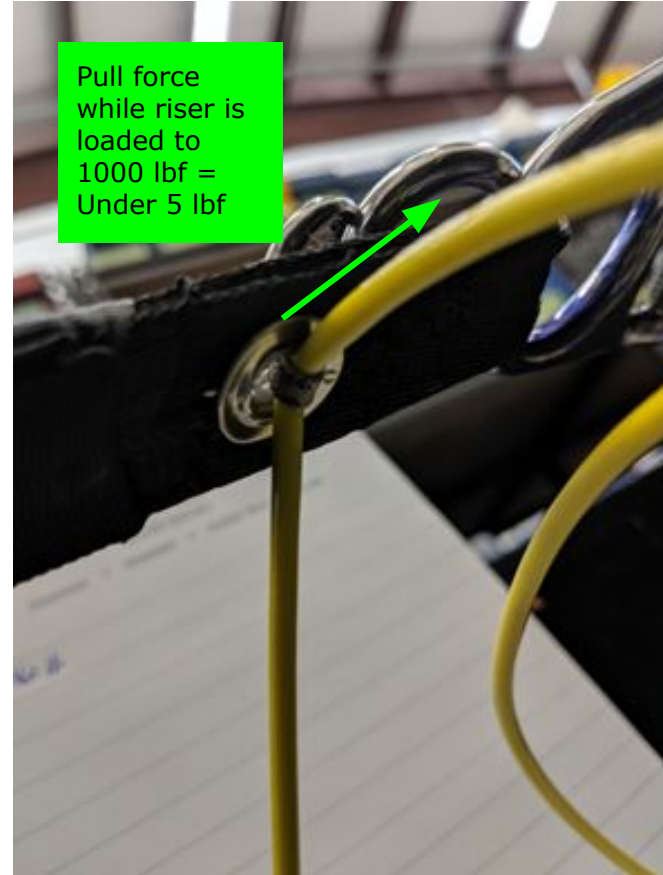
- Note: At 1000 lbf riser loading, pull force required to slide single yellow cord under white loop is under 5 lbf

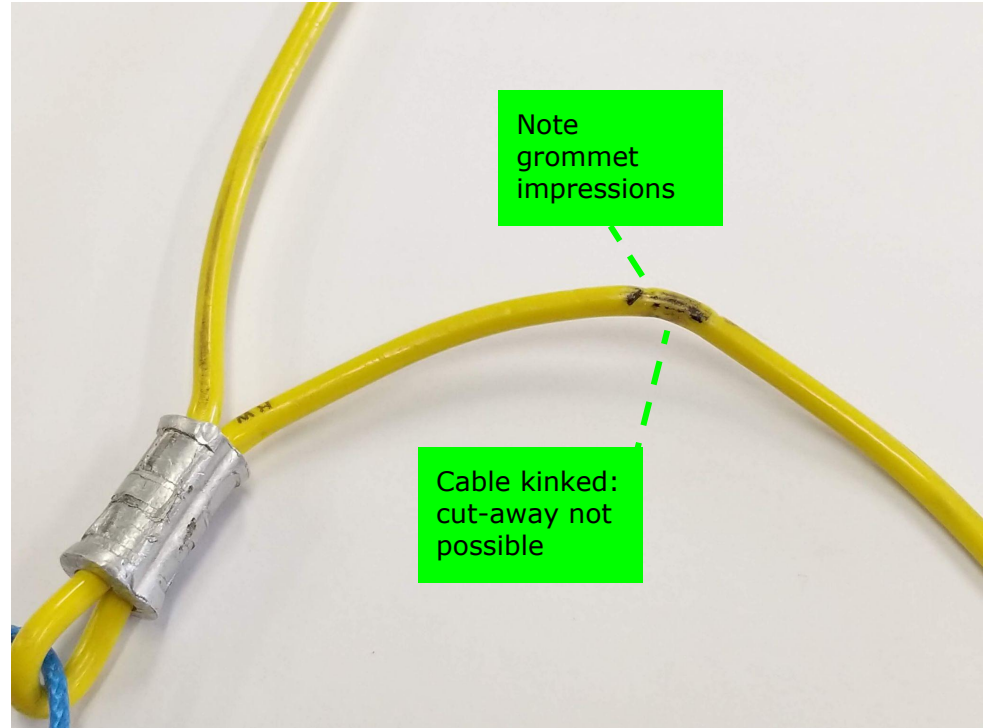
## *Cutaway function of typical mini 3-Ring system fails above 1500 lb riser loading*

- Note: At high riser loads of approximately 1,500 lbf, yellow cable becomes indented by grommet: Cutaway cable will be extremely difficult to pull.
- At extreme riser loading of approximately 3,000 lbf, the cable becomes kinked and entirely seized from movement. Cut-away would not be possible in this condition

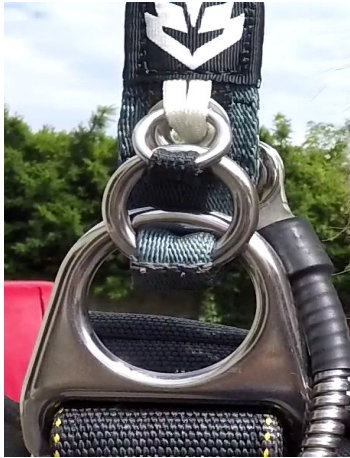
Normal 3-Ring  
Assembly

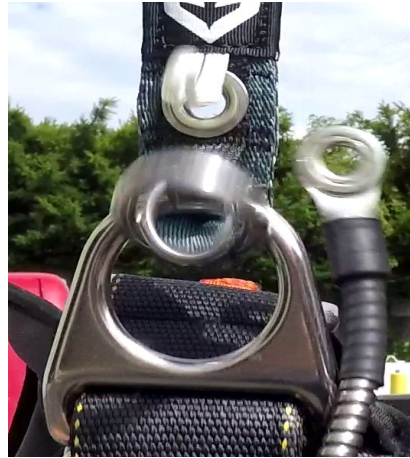
3-Ring Assembly  
at time of cutaway  
release

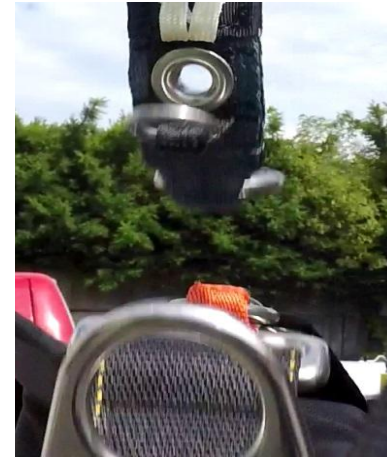
Riser released  
from main  
container D-Ring

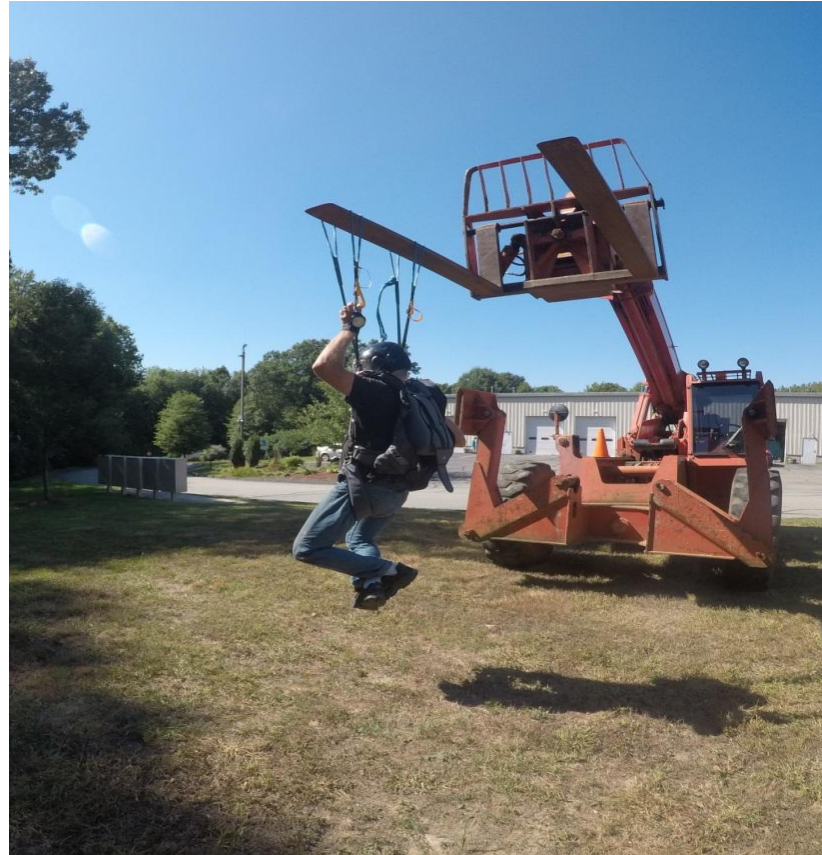
## ***Live Testing: Hanging harness cut-aways***

- Cut-away tests at low level

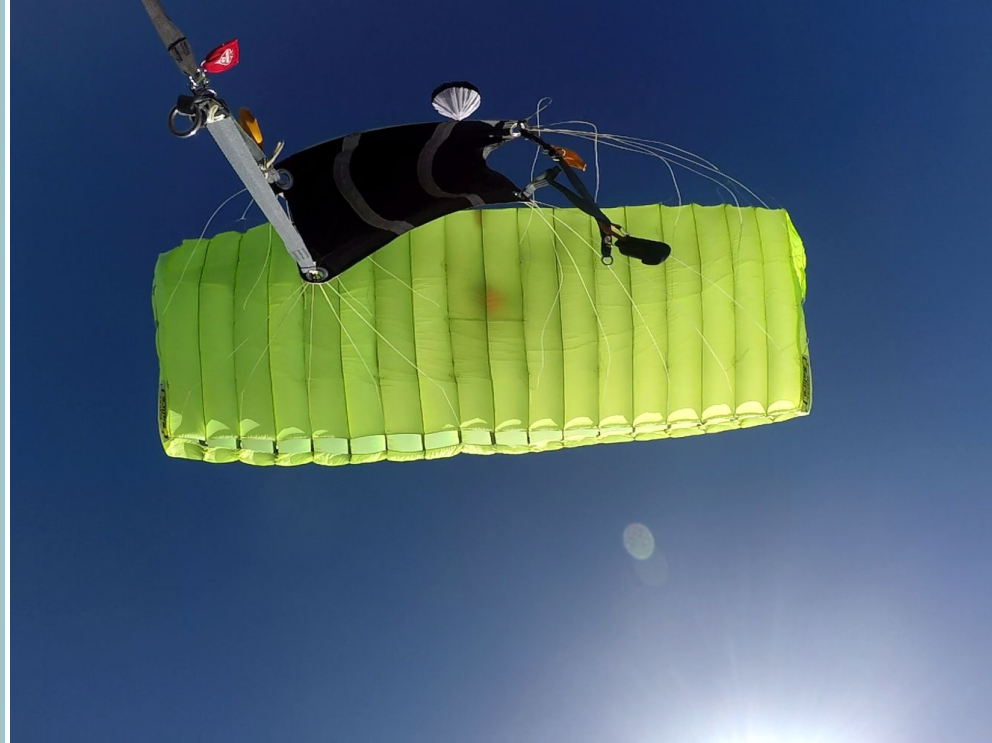
- Live cutaway test using Tylaska 3-Ring on a custom cut-away test jump rig
- Skydive cut-away
  - 6,000' AGL main release with RSL and MARD (Main Assist Reserve Deployment)
  - Immediate reserve opening by MARD
- Result: Successful cut-away done by Tim Tylaska of Tylaska Marine and Aerospace
